**Final Report**

**Airbus (AS350B3e) Helicopter, registration 9N-AMS,**

operated by Altitude Air Pvt. Ltd.

On 29<sup>th</sup> October 2025

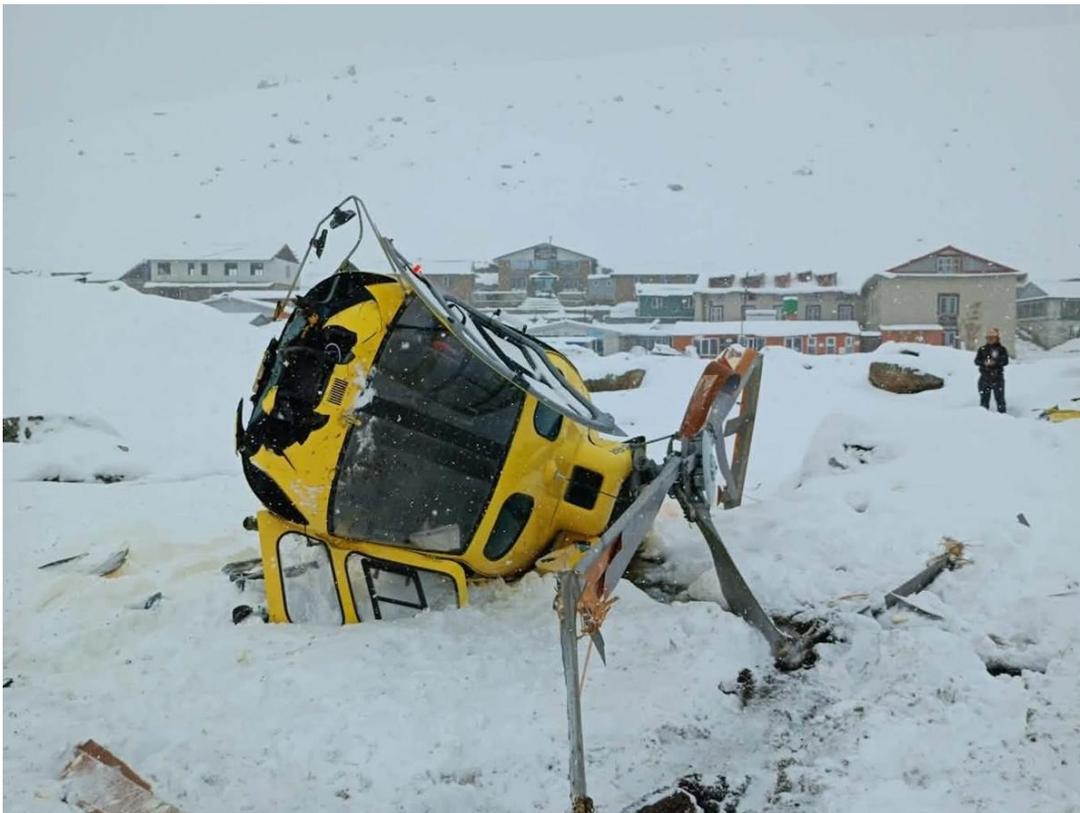
*Figure 2 Helicopter wreckage*

The helicopter sustained substantial structural damage.

Main rotor blades, tail rotor blades were damaged due to impact. The tail boom was detached and aircrafts rest position was approximately 11 meters from the touchdown point. There was no post-crash fire.

The rotor-ground impact caused the helicopter to topple. Examination confirms that the rotor strike was not a result of mechanical failure but was due to the helicopter's unstable attitude combined with the loss of external visual reference.
