**Government of Nepal
Aircraft Accident Investigation Committee 2023**

Final Report

**Accident Investigation of 9N-AJZ, AS350B3e
Owned and Operated by Simrik Air Pvt. Ltd.
At Makalu Barun Area, Siprun, Sankhuwasabha on 5th May 2023**

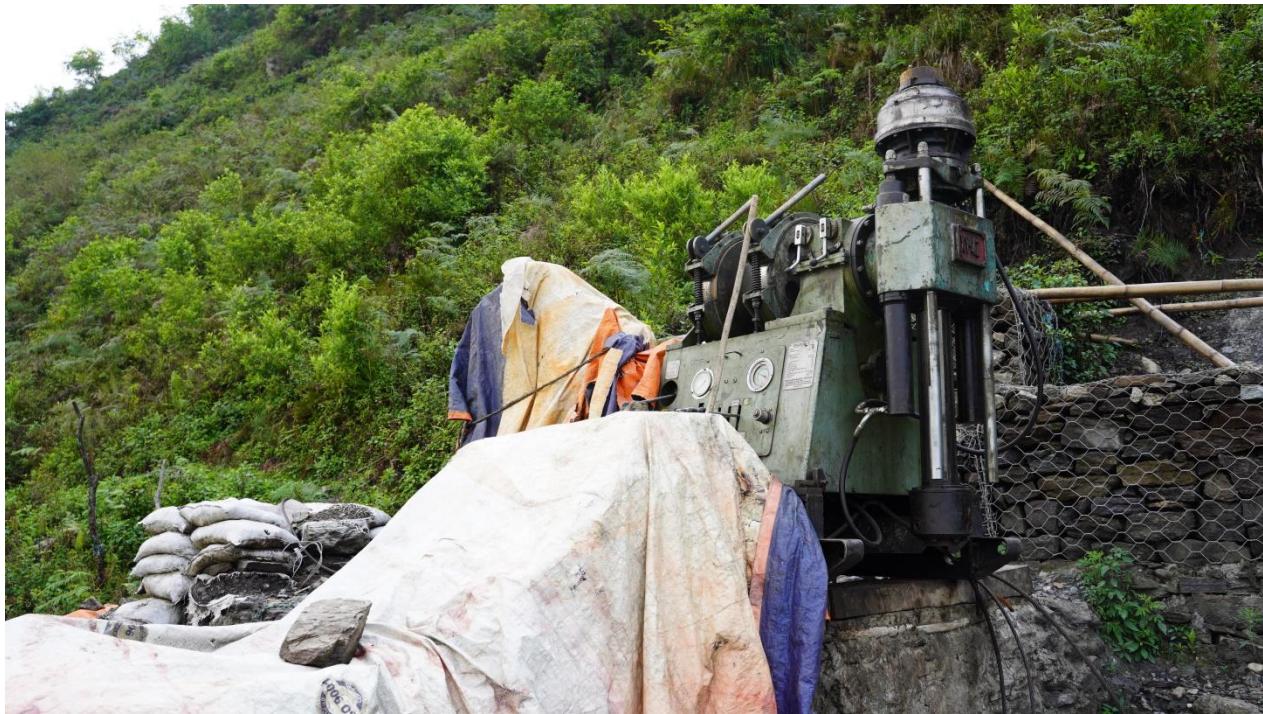
While the helicopter was on left skid contact partial hover[#] for S/N crew disembarkation followed by sling equipment unloads, pilot experienced a sudden imbalance causing a left tilt resulting in the rotor to strike the top end of a drilling machine located in the vicinity of the site.

Figure 1: Drilling machine stationed towards the east of intended point of left skid contact

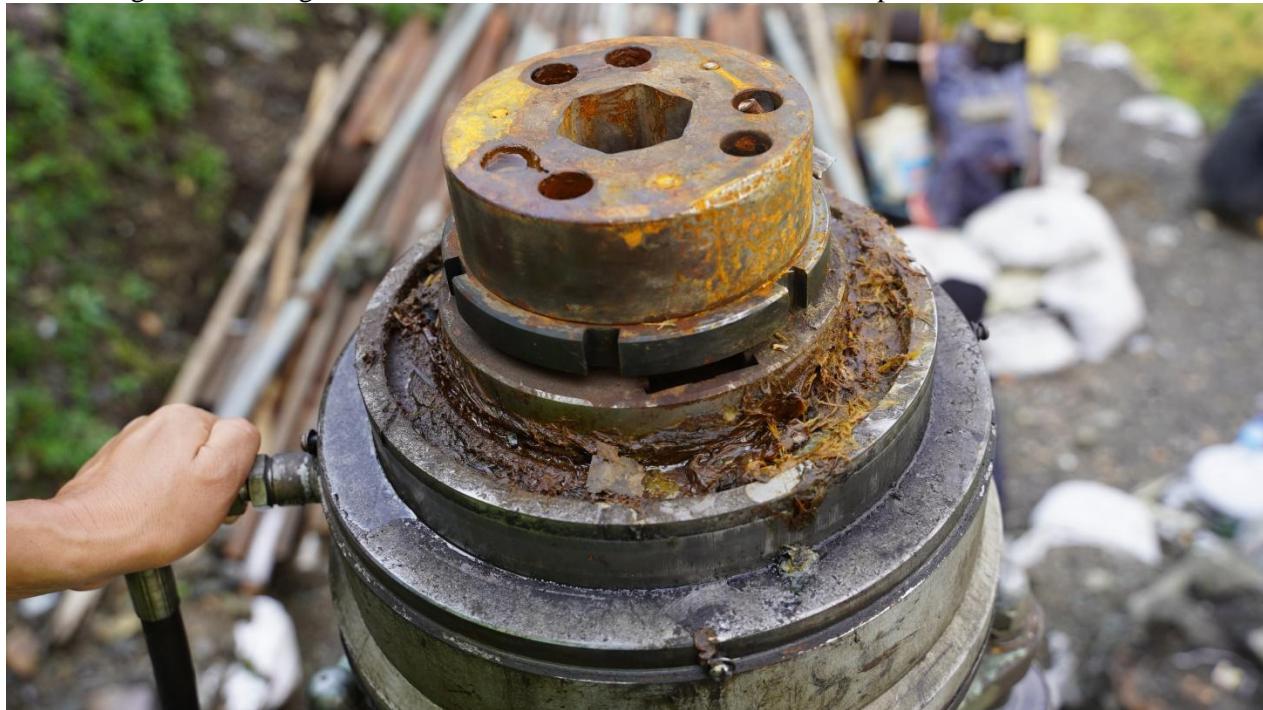
Figure 2: Impact point

by that time. However, upon minute inspection of the accident site, it is evident that the rotor impacted the top of the drilling machine causing a loss of control in flight. After that, the helicopter skid down and hit the tail rotor 8ft down the slope. The tail portion detached causing the helicopter to topple downslope several times before it came to a final rest at co-ordinates $27^{\circ} 40' 43''$ N $87^{\circ} 22' 12''$ E (Figure 5).

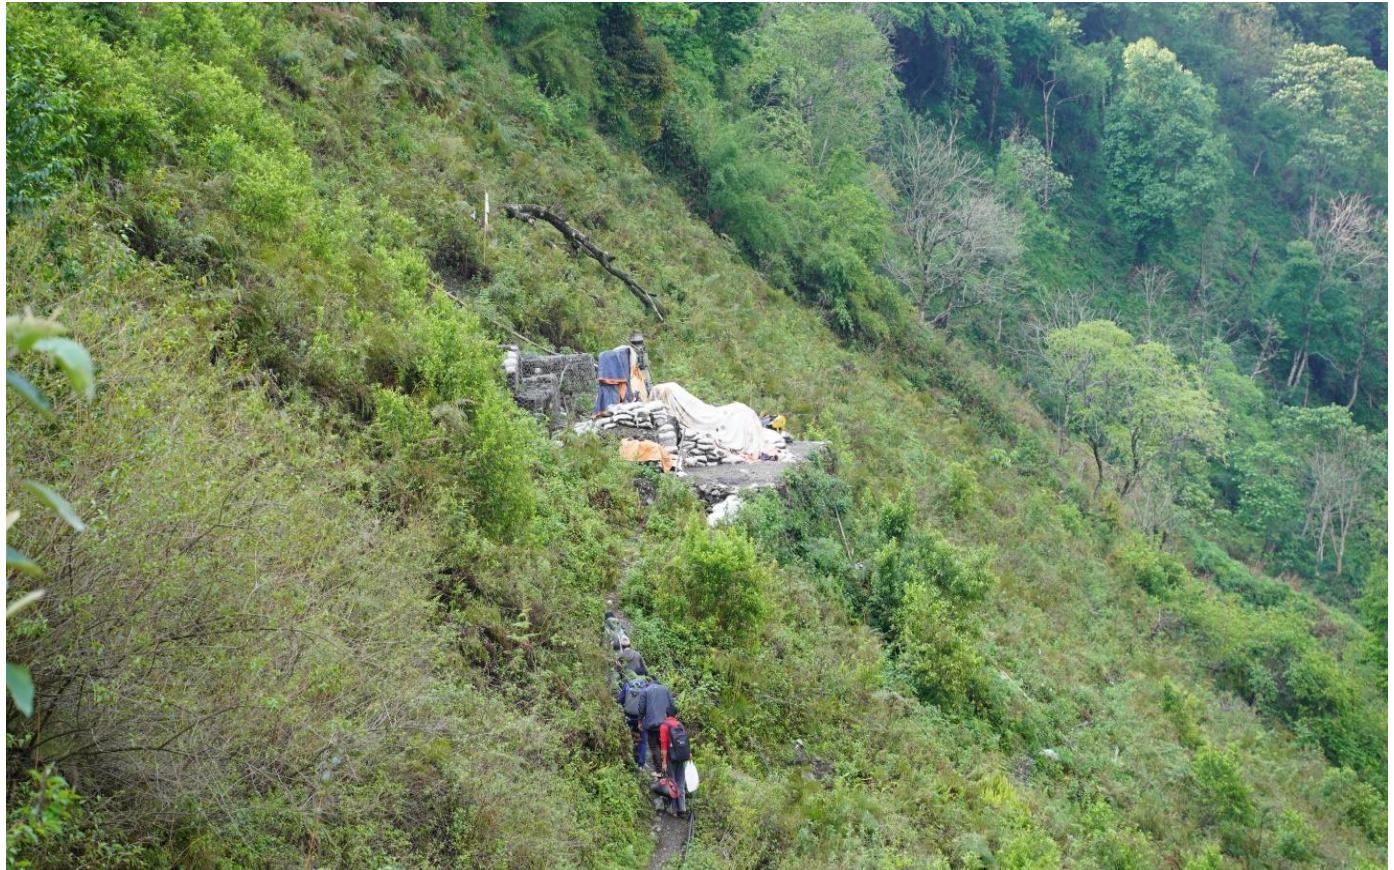
Figure 3: South view of the intended point of left skid contact

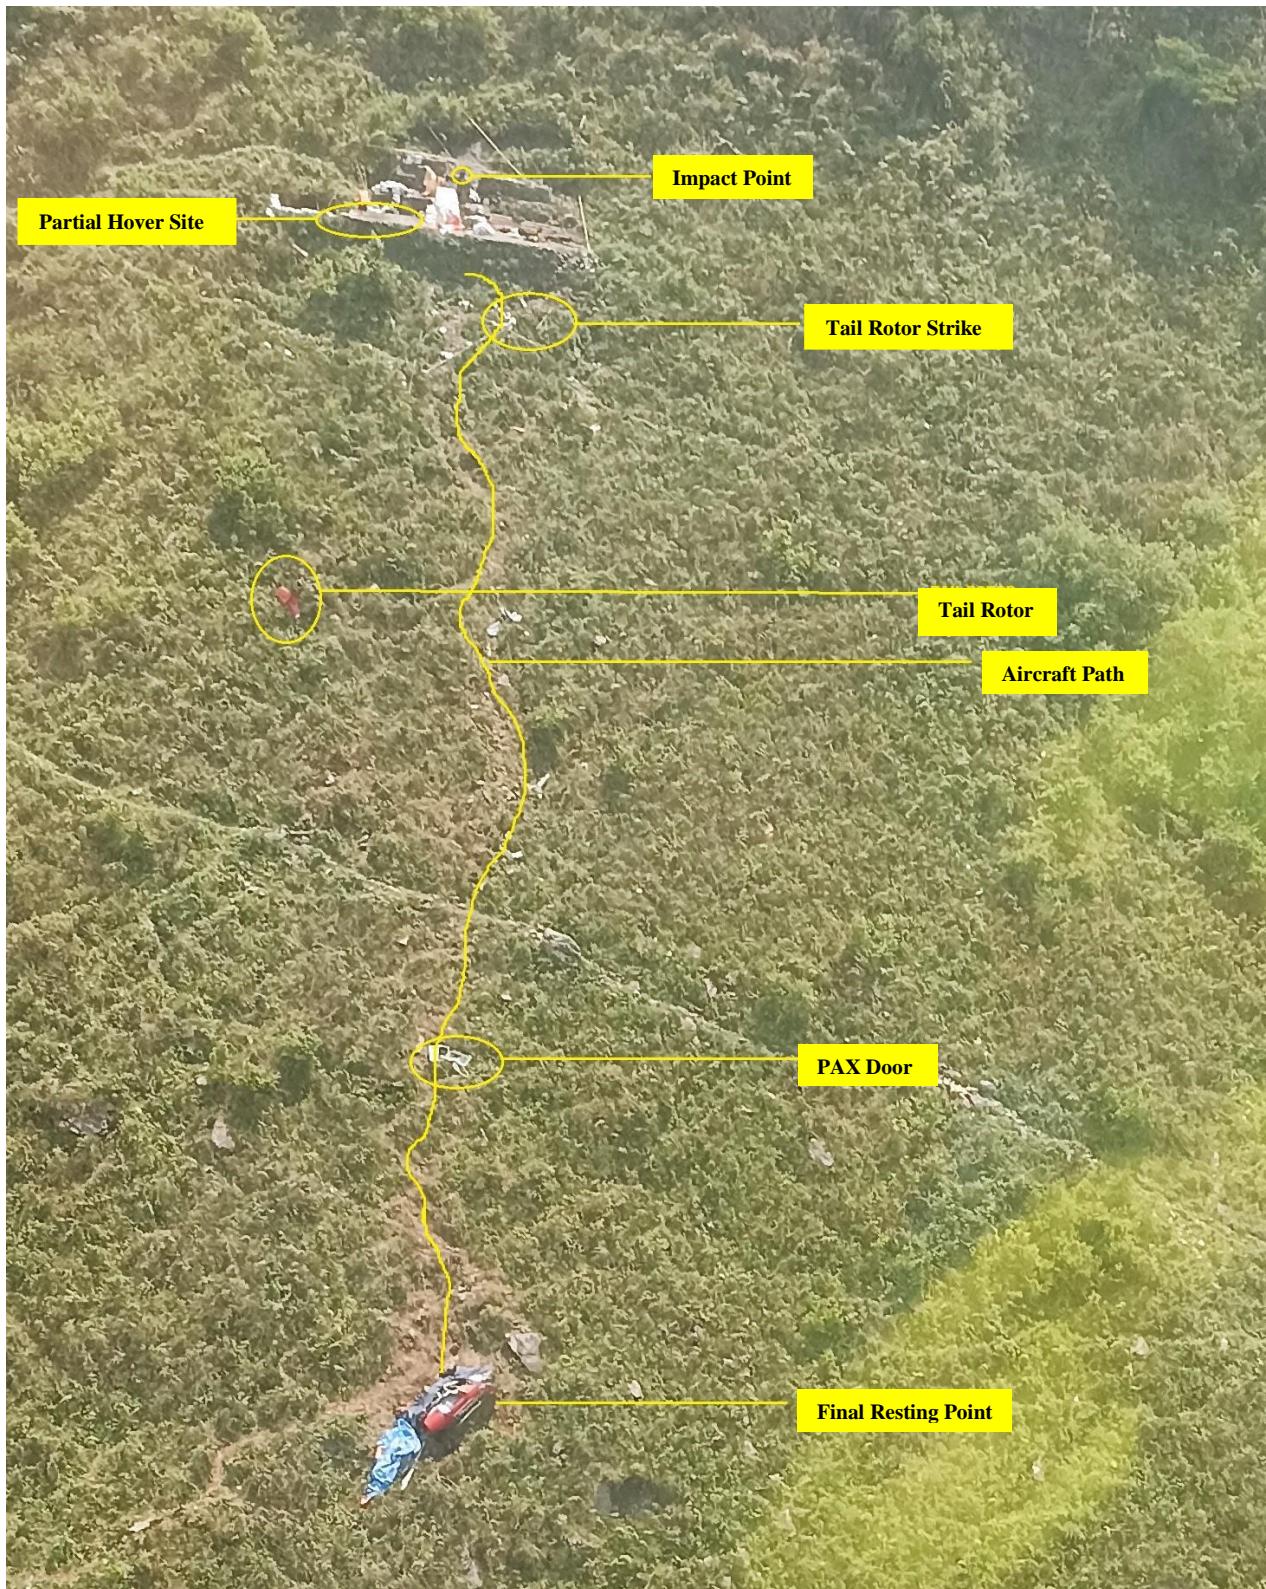
The helicopter was substantially damaged. Aircraft parts were found scattered around the vicinity as shown in Figure 4.

Due to the topographical complexities after the accident, the accident site could not be accessed immediately. The committee reached the accident site on 9th May 2023 (Figure 4). Most of the perishable information like initial impact marks and traces could not be identified and confirmed

Figure 4: Aerial View of the wreckage distribution

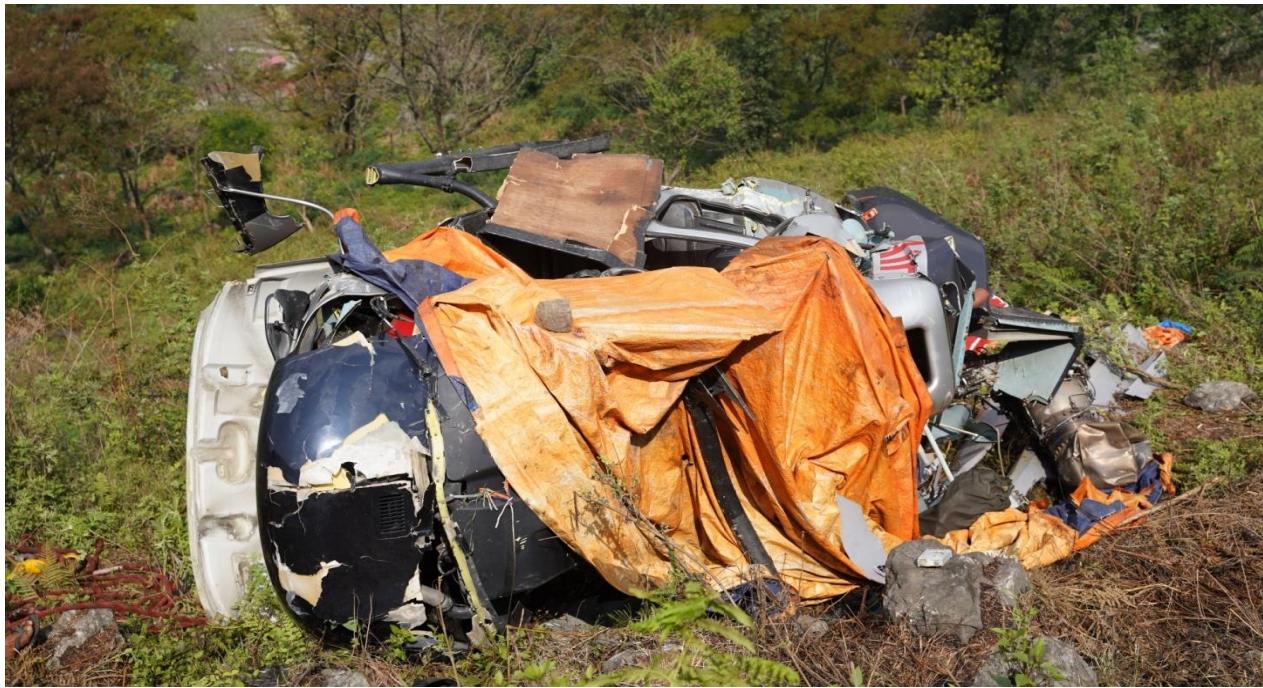
Figure 5: Helicopter Wreckage
